**U.S. ARMY CORPS OF ENGINEERS
JURISDICTIONAL DELINEATION
FOR THE
KAISER MANTECA ED EXPANSION PROJECT
SAN JOAQUIN COUNTY, CALIFORNIA**

FEBRUARY 2025 DRAFT

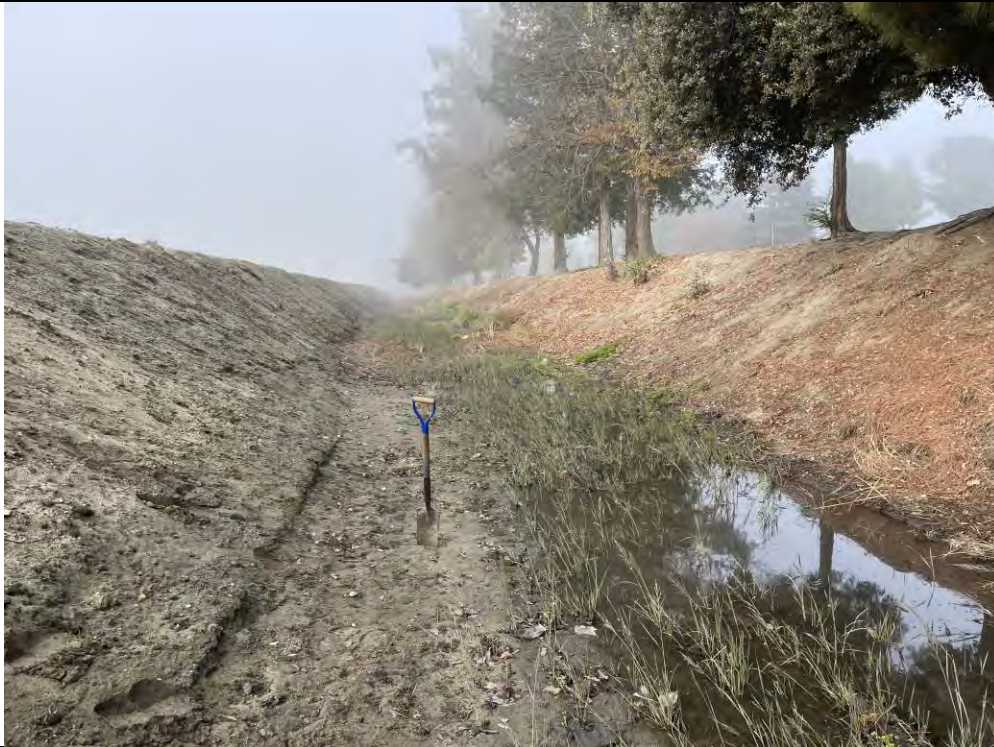
1. Facing west, the photo shows the northern intermittent drainage (Manteca Drainage 5); there was 0-6inches of water present during the time of the December 11, 2024, survey. A cut in the bank can be seen to the left of the shovel that represents the ordinary high water mark.

An intermittent drainage flows along the north boundary of the Survey Area. This feature is a portion of the Manteca Drainage 5 canal that is part of the City of Manteca's stormwater drainage system. This feature enters the Survey Area from the east, and flows west out of the Survey Area. The feature has been excavated approximately ten feet below the surrounding landscape. The banks of the feature are unvegetated and consist of loose sandy slopes. Patches of vegetation occur throughout the bed of the feature, but it is largely unvegetated.

The Manteca Drainage 5 feature is an intermittent drainage that flows along the northern boundary of the Survey Area. This feature contained areas of ponded and flowing water during the December survey and contained evidence of flow and a well-defined bed and bank throughout its course. A delineation of the adjacent, upstream portion of this feature was verified in 2022 (SPK-2022-00525) and was determined to not fall under Corps jurisdiction due to a lack of downstream connectivity to any Traditional Navigable Water. As there have not been any changes in conditions

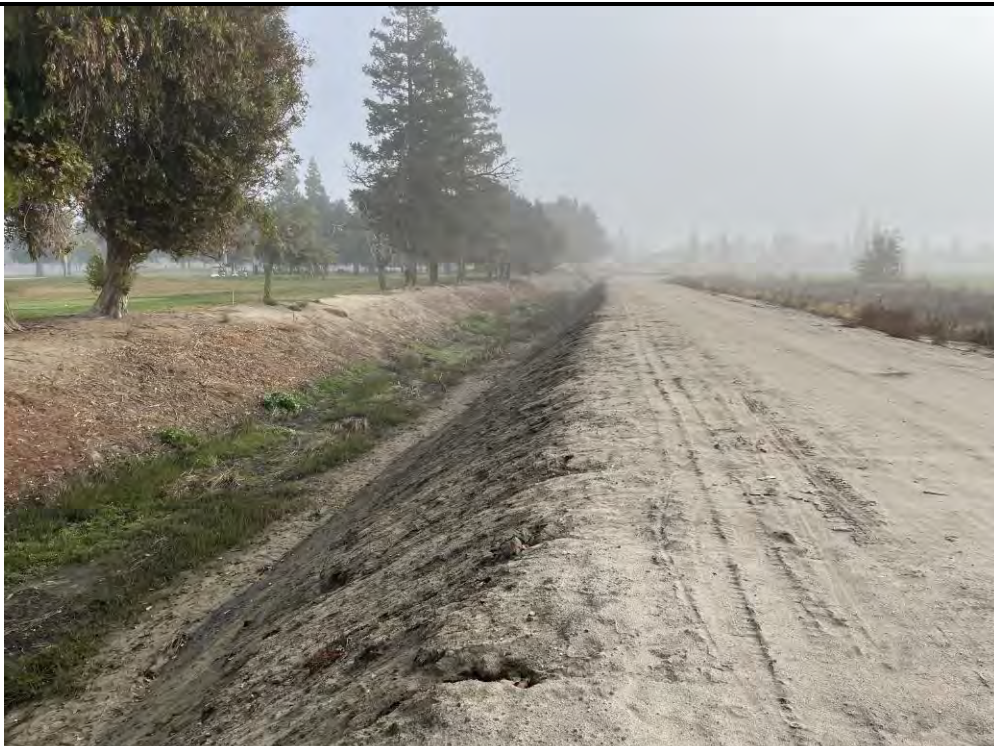
2. Facing east, the photo shows the top of bank and bank slope of Manteca Drainage 5, the gravel access road in the middle, and the seasonal wetland (SW 1) to the right of the photo.

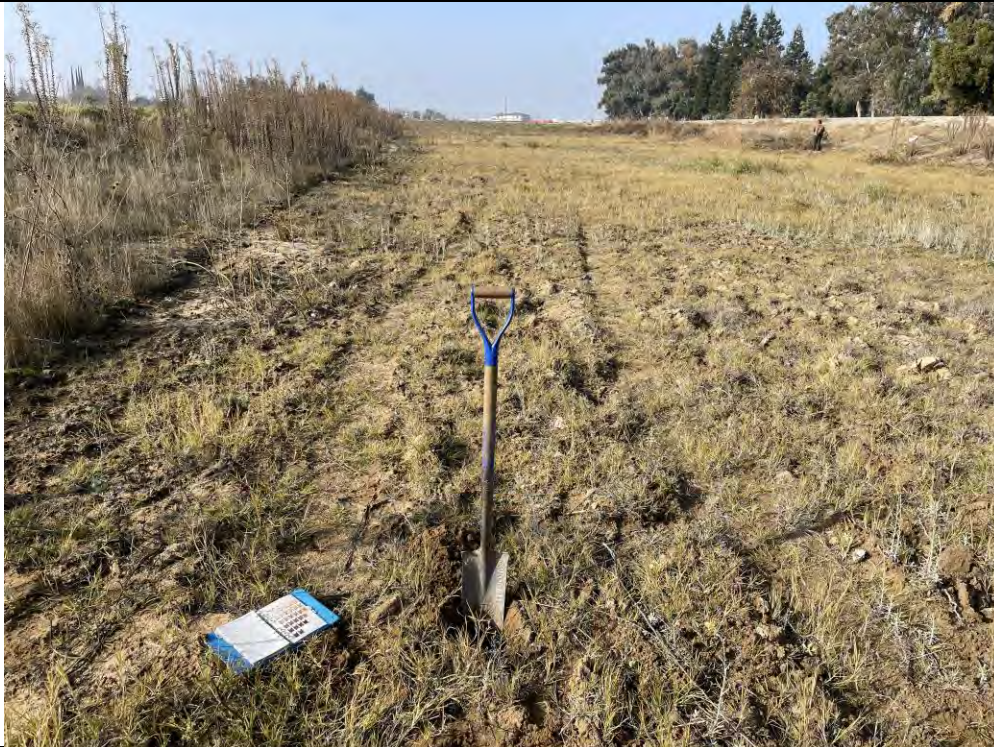
3. Facing west, the photo shows sample point 2b and the western portion of feature SW 1.

grass, tall flat sedge, and cotton-batting plant. The soil samples within this feature had the consistency of silty-sand. The western sample points had a soil matrix color of 10 YR 4/3 with redox concentrations of 5 YR 4/6. The sample point taken in the eastern portion of the feature had a matrix color of 2.5Y 5/2, with redox depletions of 5Y 3/1. While no ponding or saturation was observed within the feature, the soil samples were moist and other hydrology indicators were present including sediment deposits, biotic crust, aquatic invertebrates, and oxidized rhizospheres along living roots.

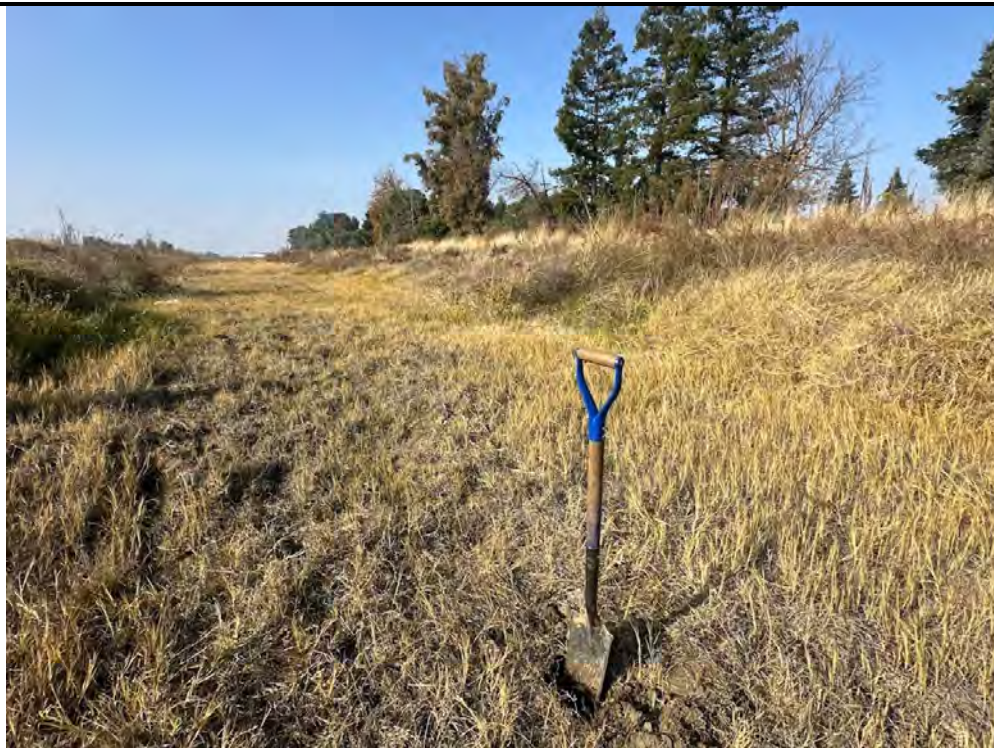
4. Facing west, the photo shows sample point 3b, and the eastern portion of feature SW 1.

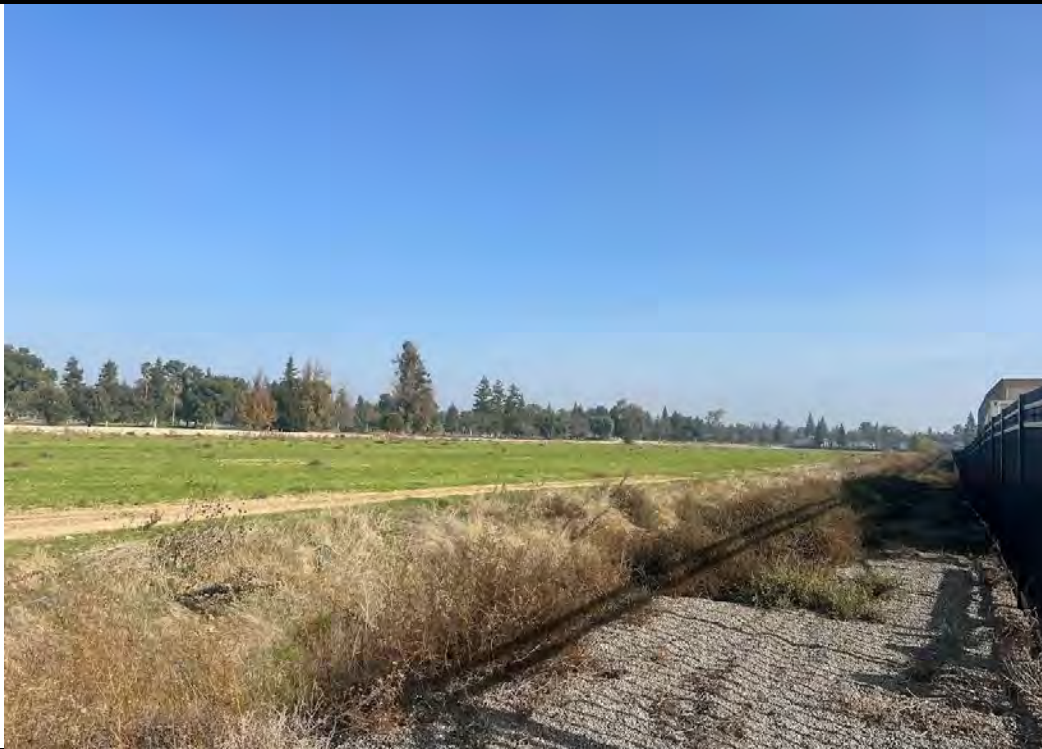
5. Facing east, the photo shows a portion of the ephemeral drainage feature ED 1a. The drainage feature contained large amounts of Russian thistle (*Salsola tragus*).

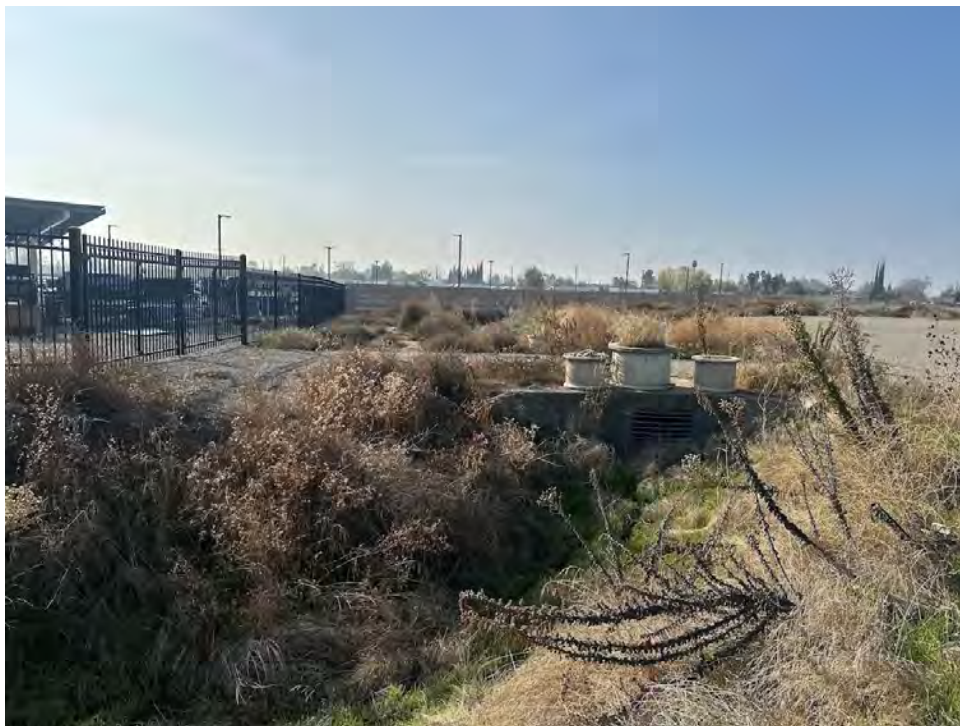
6. Facing southwest, the photo shows the west end of feature ED 1a, and the box culvert that allows water to flow under the gravel access road into feature ED 1b.

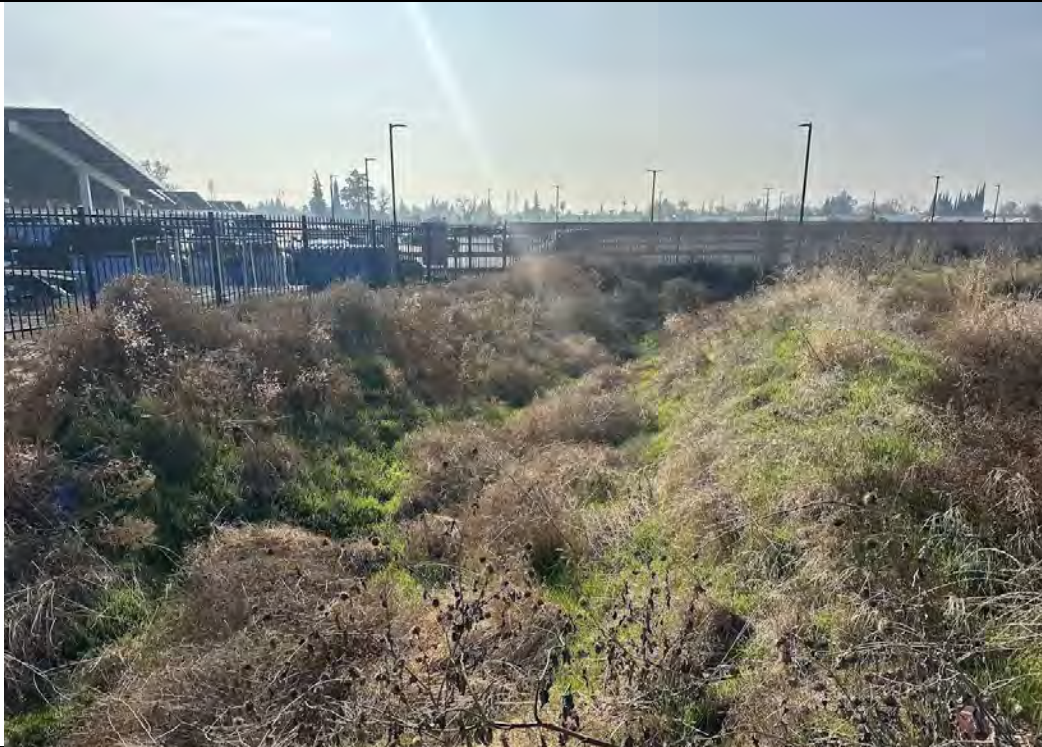
7. Facing southwest, the photo shows a portion of feature ED 1b. The feature contains large amounts of Russian thistle.

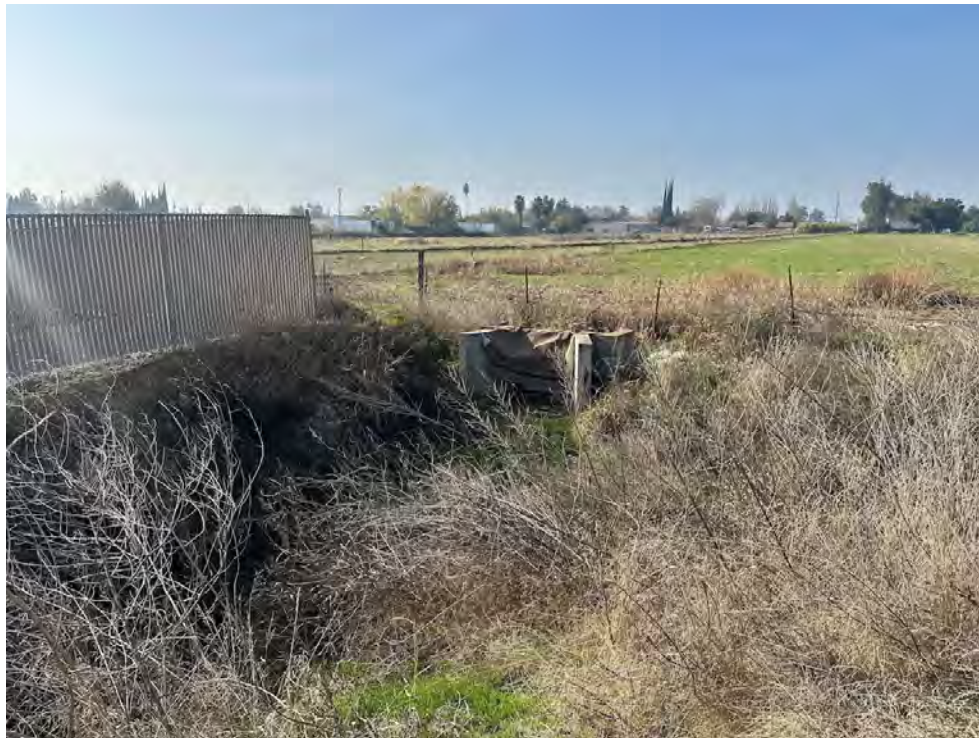
8. Facing west, the photo shows the culvert, located outside of the Survey Area, where water from feature ED 1b flows underground into the stormwater drainage system.
